33-KILOVOLT POWER LINE NASSRIYA, IRAQ

SIGIR PA-08-127
JULY 22, 2008

SUBJECT: Report on Construction of the 33-Kilovolt Power Line, Nassriya, Iraq (Report
Number SIGIR PA-08-127)

33-Kilovolt Power Line, Nassriya, Iraq

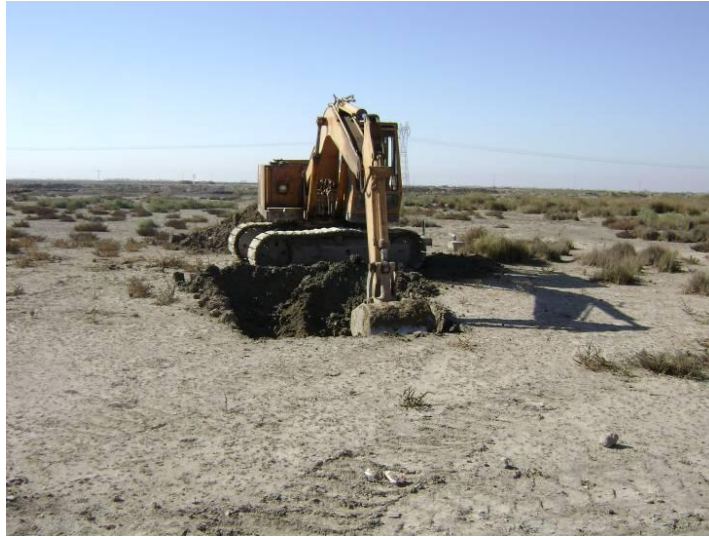
Site Photo 3. Excavation for tower foundation (Courtesy of the USACE))

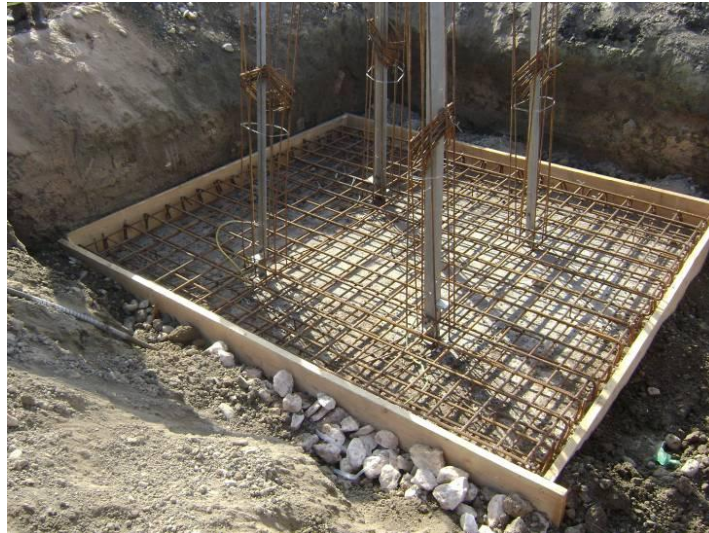
Site Photo 4. Forming up tower foundation (Courtesy of the USACE))

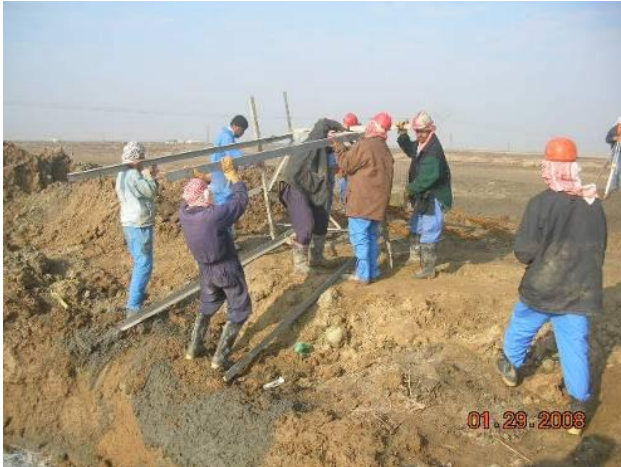
Site Photo 5. Erecting base of tower
(Courtesy of the USACE)

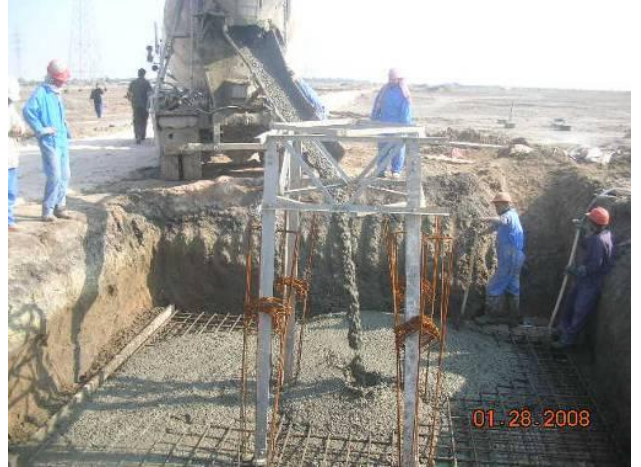
Site Photo 6. Concrete pour for tower
(Courtesy of the USACE)

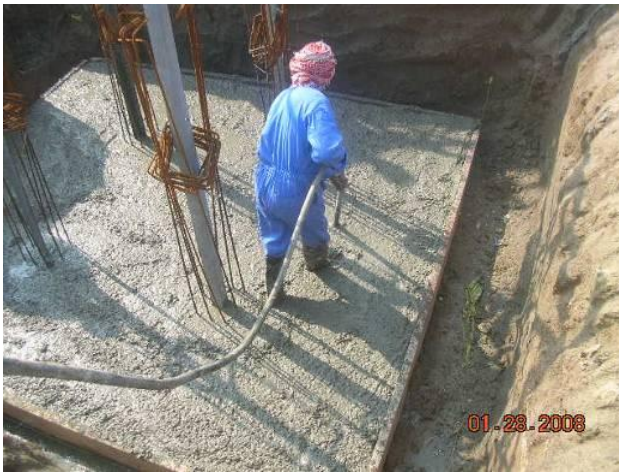
Site Photo 7. Vibrating concrete
(Courtesy of the USACE)

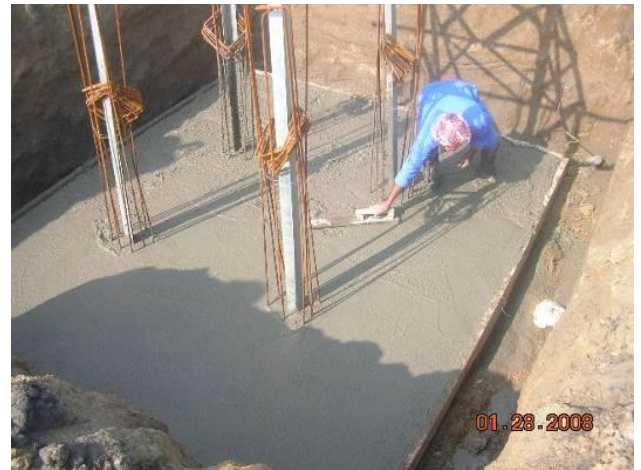
Site Photo 8. Finishing concrete
(Courtesy of the USACE)

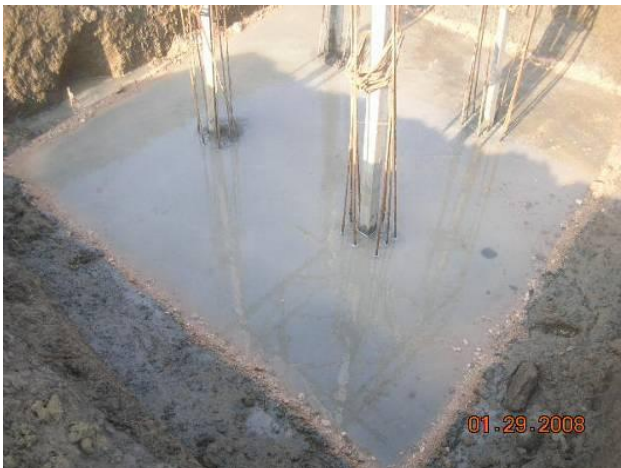
Site Photo 9. Curing concrete
(Courtesy of the USACE)

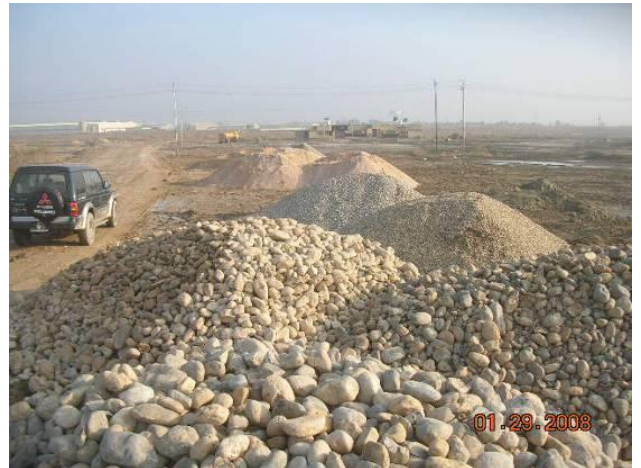
Site Photo 10. Aggregate delivered to site
(Courtesy of the USACE)
